# Manhole Inspection Summary

Manhole # S31UU1001MH

Insp Date: **1/16/07 10:39 AM**

**Location** Address: **200 PADDINGTON RD**

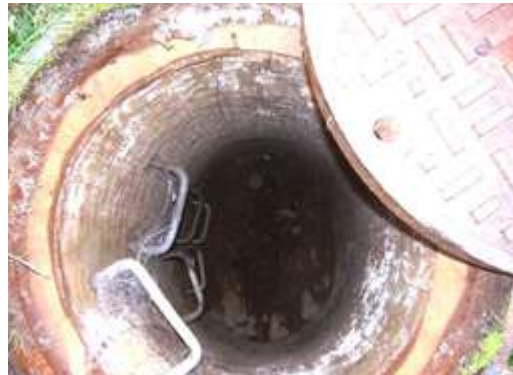
Top View

**Channel** Material: **Brick** ☐ Parged ☒ **Debris** (not Condition related)

Channel debris.

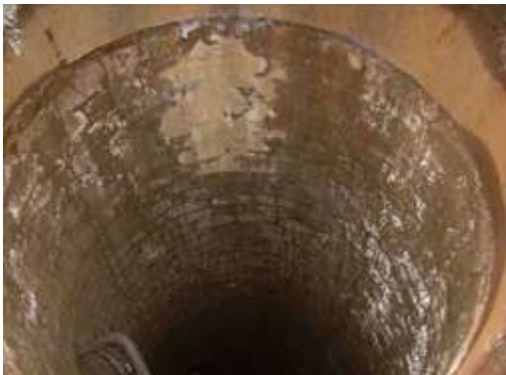
Defect

Infiltration: ☐ None ☒ **Joint** ☐ Cracks ☒ **Mortar** ☐ Roots ☐ Wall

Adjustment infiltration.

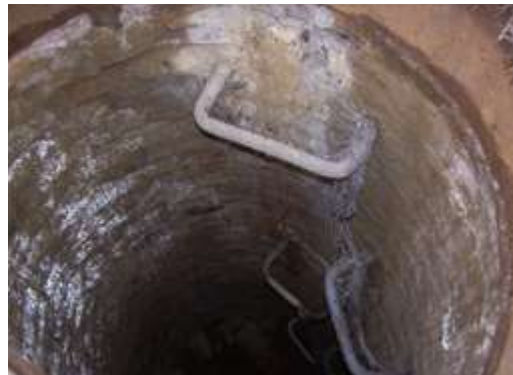
Defect

Adjustment infiltration - other side.

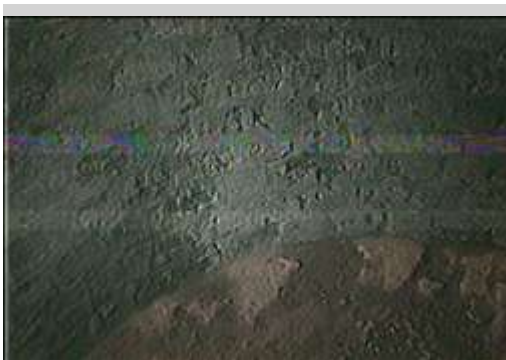
Defect

Infiltration: ☐ None ☐ Joint ☐ Cracks ☐ Mortar ☐ Roots ☒ **Wall**

Barrel infiltration.

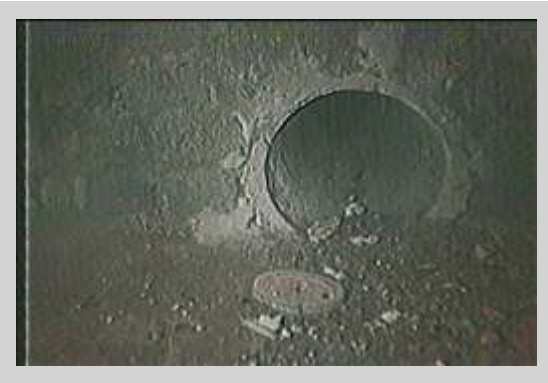
8 in. Circular Gravity Sewer  
Pipe Out @ 12 O'Clock

Channel debris.

Deposits: ☐ None ☒ **Mud** ☐ Sludge ☒ **Debris** ☐ Grease

Silt Depth: **0** (in.) Deposits Extent: **Light**
